coke gas treatment reduces underfire system corrosion and risks

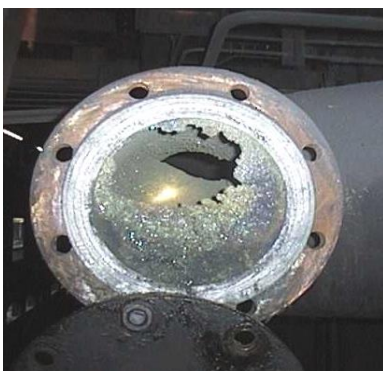
Due to corrosion in the transfer lines to the ovens, gas leaks occurred frequently. These leaks of highly combustible coke oven gas are not only a source of air pollution, but the repair work, under difficult and high-risk conditions, is expensive (see image below).

The underfiring system of a Belgian Coke Plant was suffering from fouling, deposits from tar, naphthalene, salts and under deposit corrosion. The corrosion resulted in gas leaks, which created safety risks, air pollution and high-risk repair work.

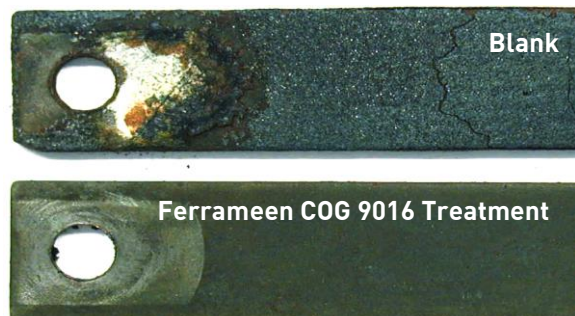
A few days after starting the Ferrameen COG9016 dosing, a reduction in the fouling of the orifices and flexible piping was already noted. After one month the first series of coupons was taken out of the system for inspection. The untreated coupon (top image) was already heavily fouled and showed underdeposit corrosion. The treated coupon (bottom image) was clean and showed no deposits or corrosion.

On one side of a battery, SUEZ Water Technologies & Solutions started dosing Ferrameen* COG9016 at a concentration of 0.2 L / 10,000 Nm³. We installed retractable coupons in the treated line and also, as blank, in the untreated line.
